Executive Summary

Engineer's Foundation Evaluation

123 Sample Address, Your City, GA, 12345

On 12/31/2024 a foundation evaluation was performed at the property located at address 123 Sample Address, Your City, GA, 12345, which consists of a 2042 square-foot single family attached structure built in 2005 with a slab on grade foundation.

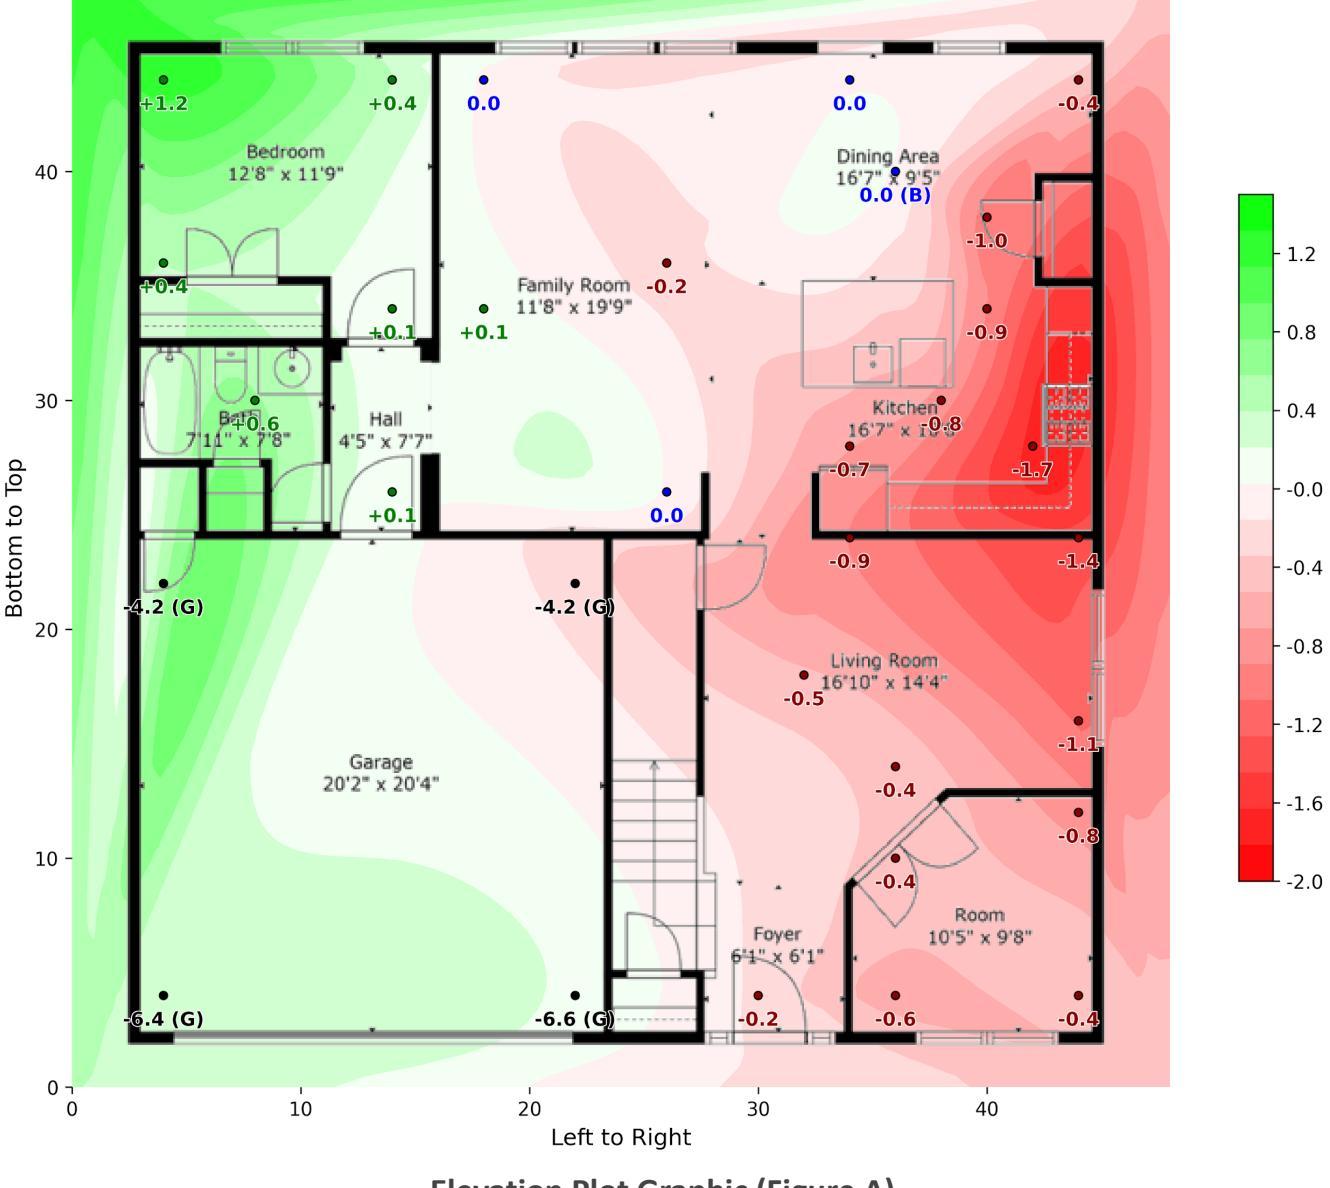
The elevation plot resulted in the graphic as depicted above in Figure A. The red-points and areas are elevation measurements that were lower than the base station elevation (0.0). The green-points and areas are elevation measurements that were higher than the base station elevation (0.0). The blue-points (and white areas) are equal to the base station elevation (0.0). The maximum elevation point was determined to be 1.2 inches and the minimum was -1.7 inches, resulting in an elevation difference of 2.9 inches of difference across the structure.

As documented above, the maximum elevation point of this structure was determined to be 1.2 inches and the minimum was -1.7 inches, resulting in an elevation difference of 2.9 inches of difference across the structure. The elevation deflection across an entire structure should remain within 0.5 to 1-inch depending on the age of the structure. Measured differences approaching 2-inches are a sign of foundation fatigue. The maximum allowable elevation difference is subjective, depending on other factors such as the visual condition and age of the structure (20 year(s) old).

Based on observed elevations of the foundation from the elevation plot, the structure cannot be considered fully stable. Elevation differences do not fall within industry standards or tolerable limits. These findings indicate that the foundation does not have consistent and uniform elevation demonstrating continued movement of the foundation.

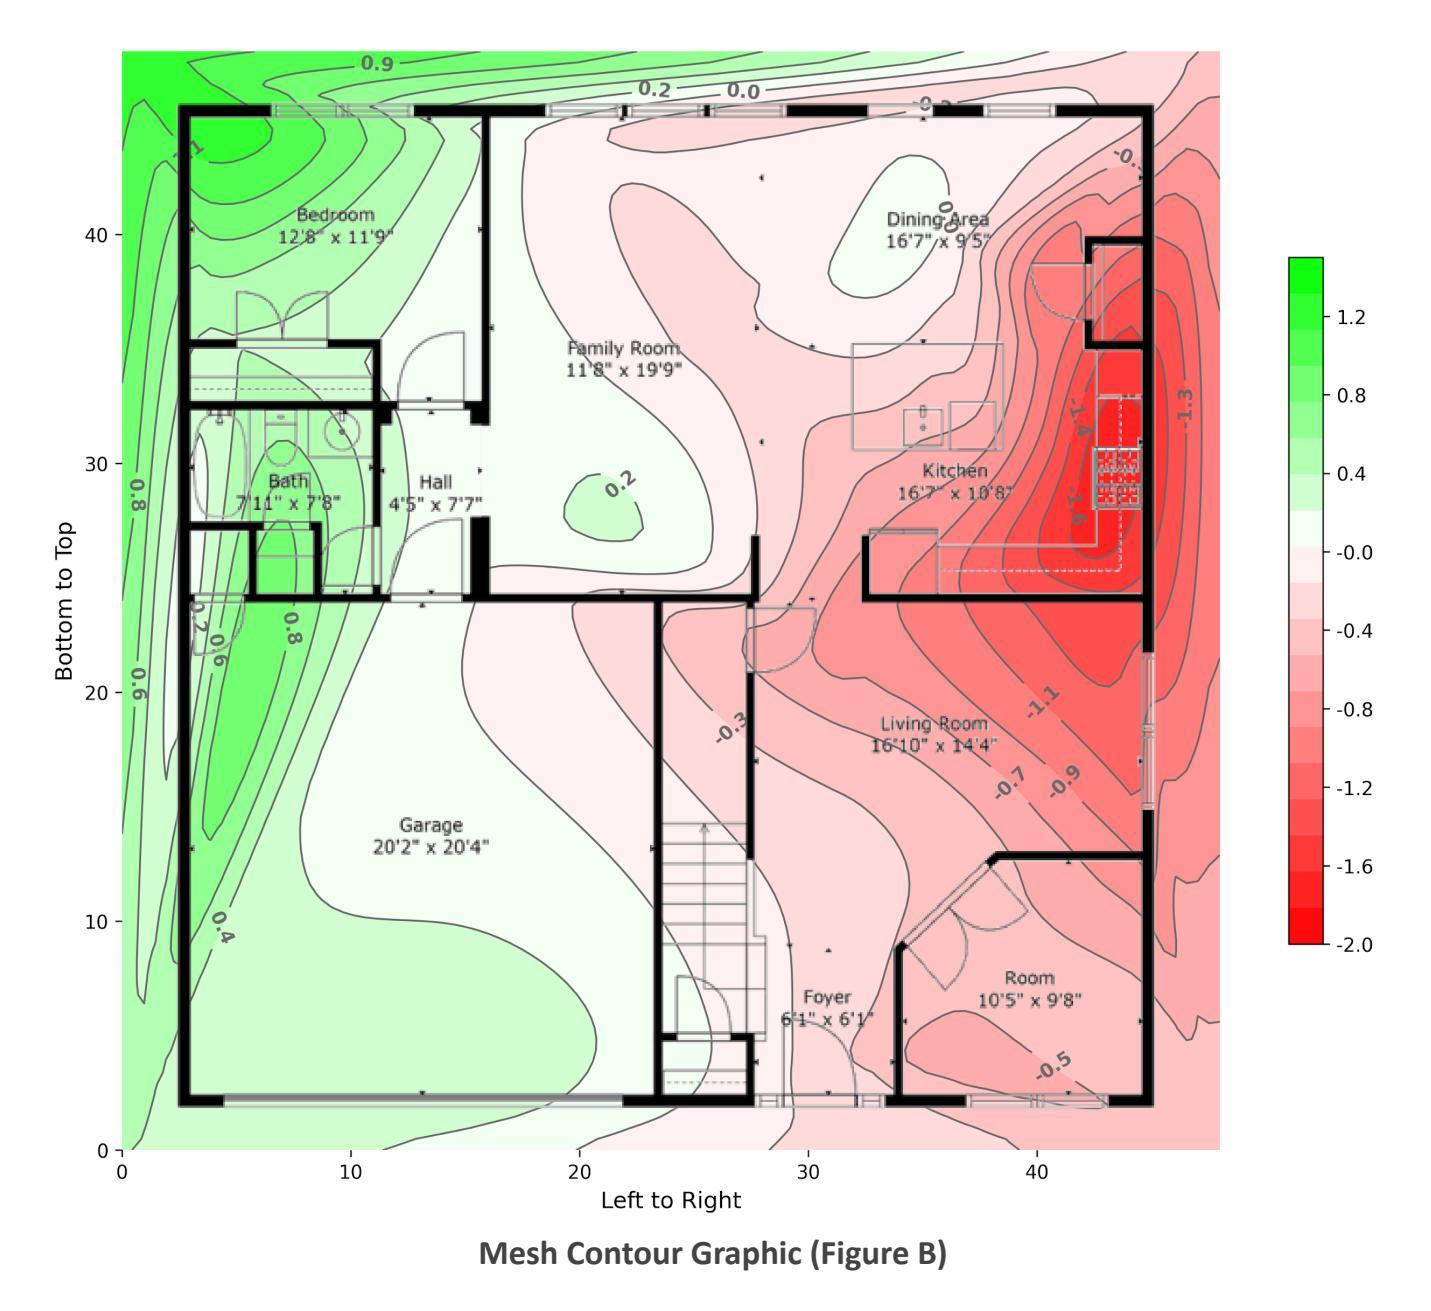
The mesh contours graphic depicted above in Figure B is similar to the elevation plot. The red, green, and white areas depict areas that are lower, higher, and equal to the base station elevation (0.0). The contour intervals are labeled.

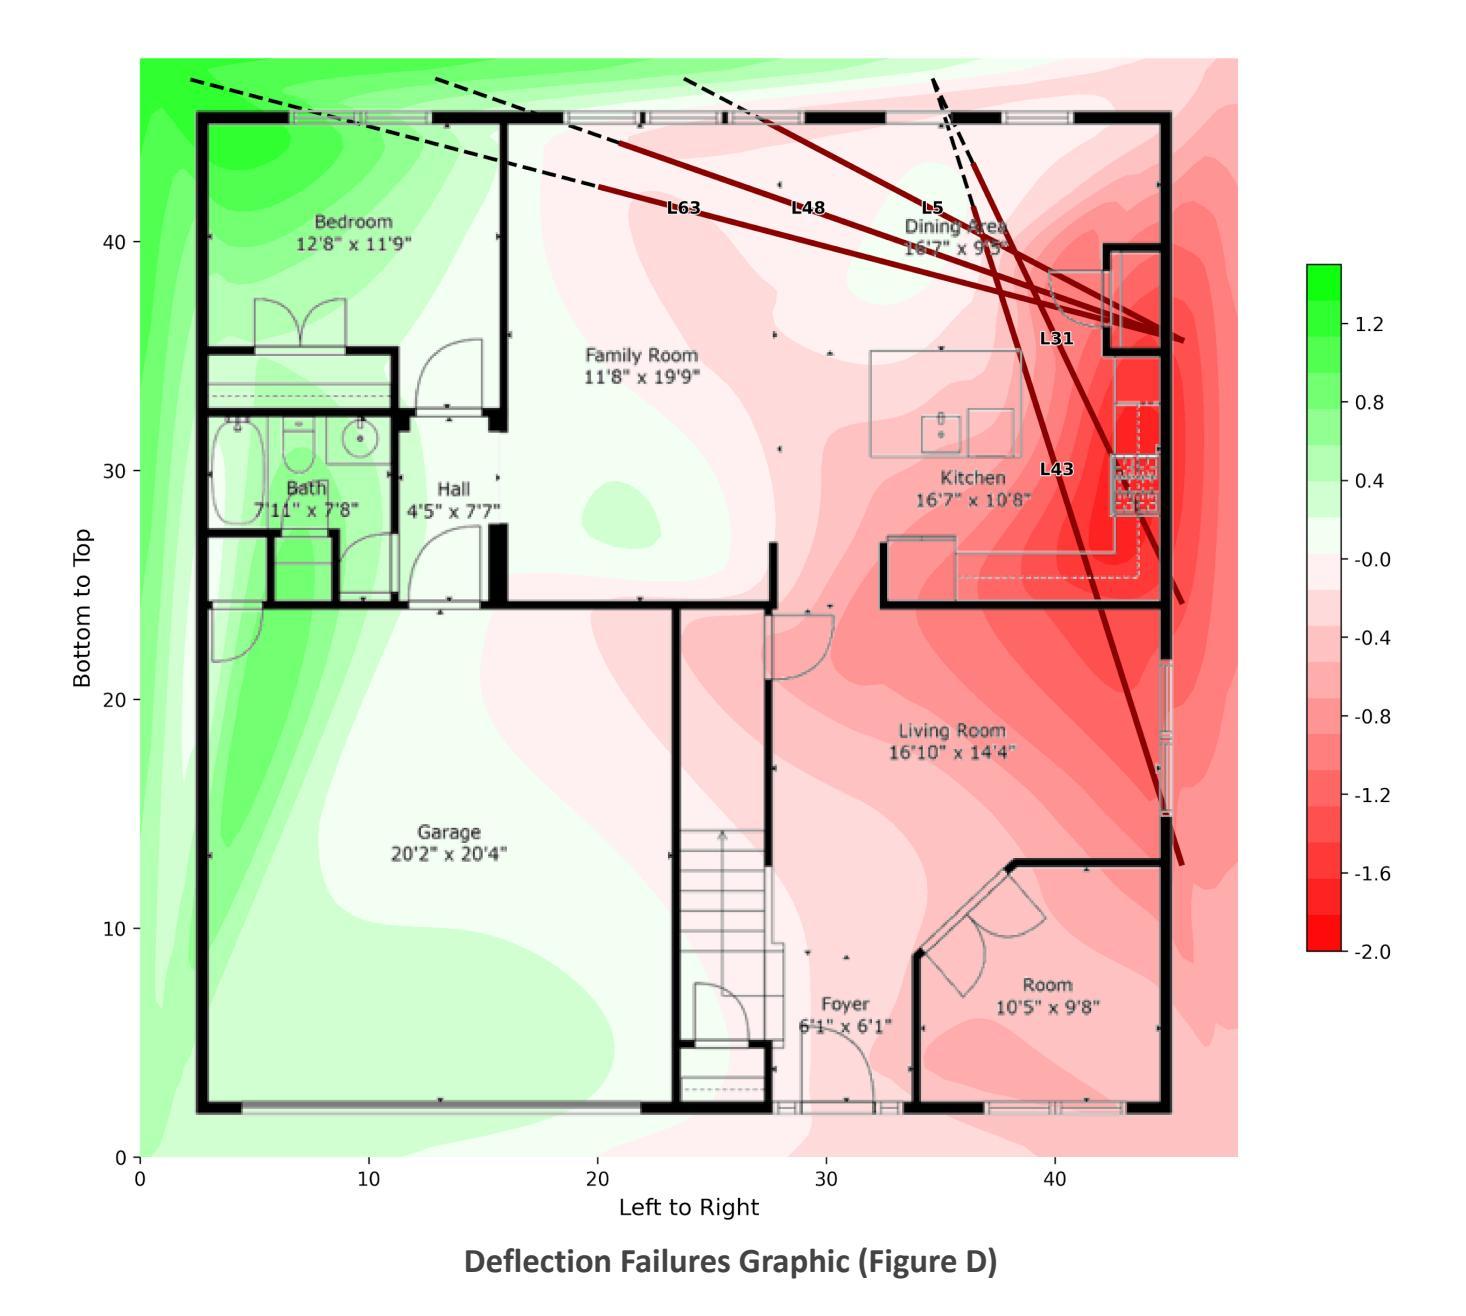
The above Figure D shows deflection failures along the foundation. Deflection failures can be considered localized failures in (sometimes) isolated portions of the foundation. The profile lines that were calculated are represented by a dashed black line and the areas that the deflection failures occur are represented by a dark red line segment. Of the 76 deflection profiles calculated, 5 profile failures were identified.

Deflection failures can be considered localized failures of the foundation in (sometimes) isolated portions of the foundation. Of the 76 deflection profiles calculated, 5 failures were identified.

Deflection failures are above standard acceptable limits; they exceed industry-standard thresholds and the structure should be considered actively moving/settling in areas where deflection failures are occuring.

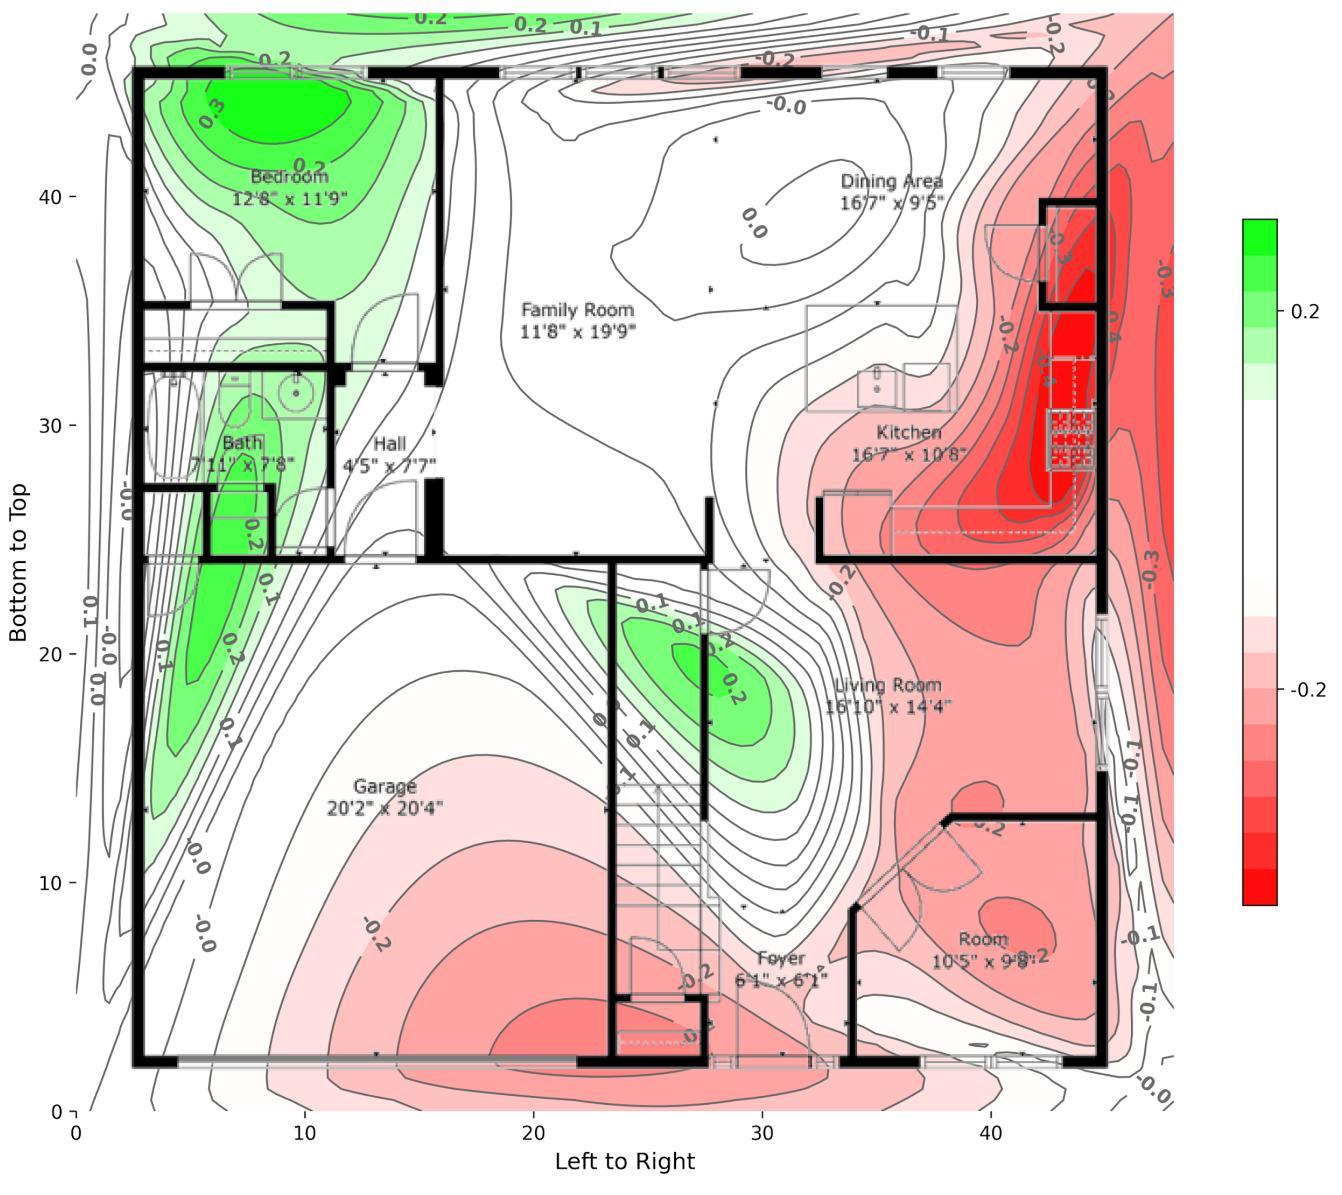
Elevation Plot Difference Graphic (Figure F)

The mesh contour graphic above in Figure F shows areas in red that are lower than the baseline elevation plot and areas of green that are higher than the baseline elevation plot (from the provided drawing completed in 1998). The darker the color (both red and green) the larger/smaller the elevation differences.
