Executive Summary

Engineer's Foundation Evaluation

123 Sample Address, Your City, GA, 12345

On 12/31/2024 a foundation evaluation was performed at the property located at address 123 Sample Address, Your City, GA, 12345, which consists of a 2042 square-foot single family attached structure built in 2005 with a slab on grade foundation.

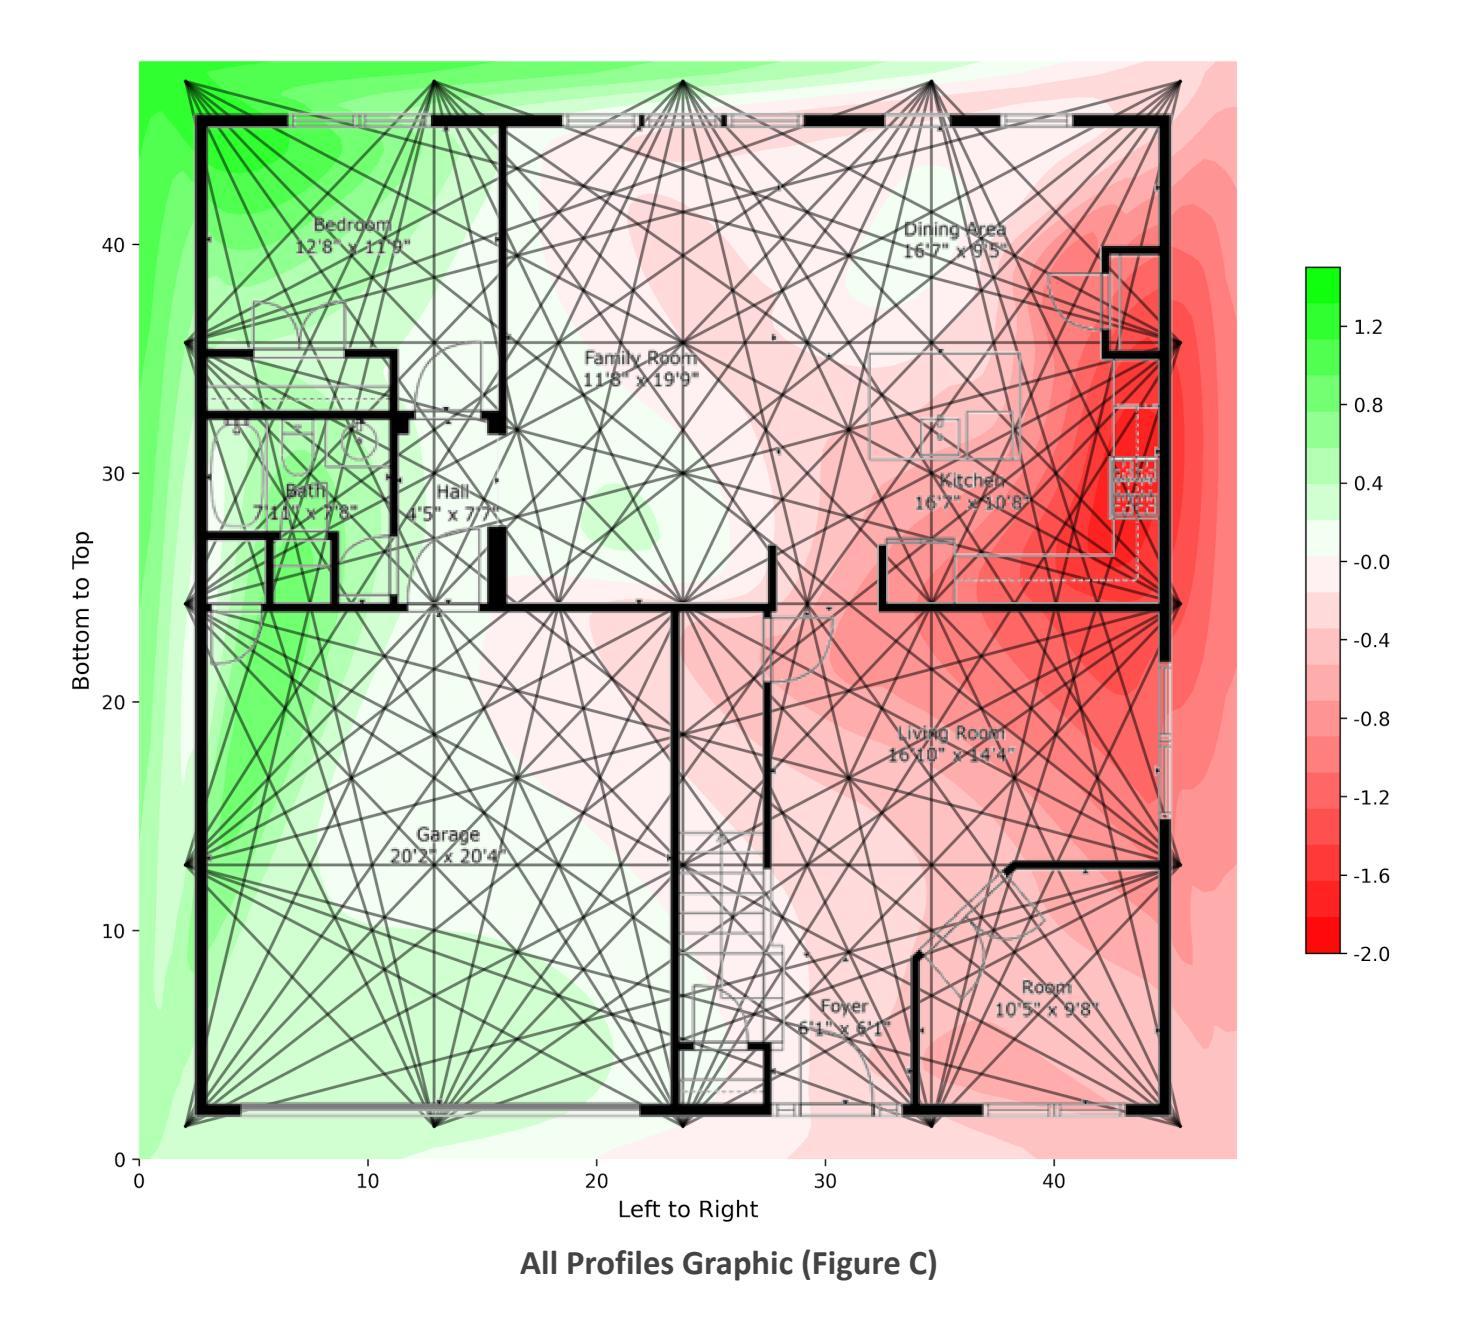
Below is a graphic that shows the locations of deflection and tilt profiles that were calculated. The total profiles calulated was 79 with a total usable profiles (above the effective length threshold) of 76.
